CRITICAL INFRASTRUCTURE REPAIRS

GENERAL ASSEMBLY BUILDING

January 12, 2007

Richard F. Sliwoski P.E.
Director
Department of General Services

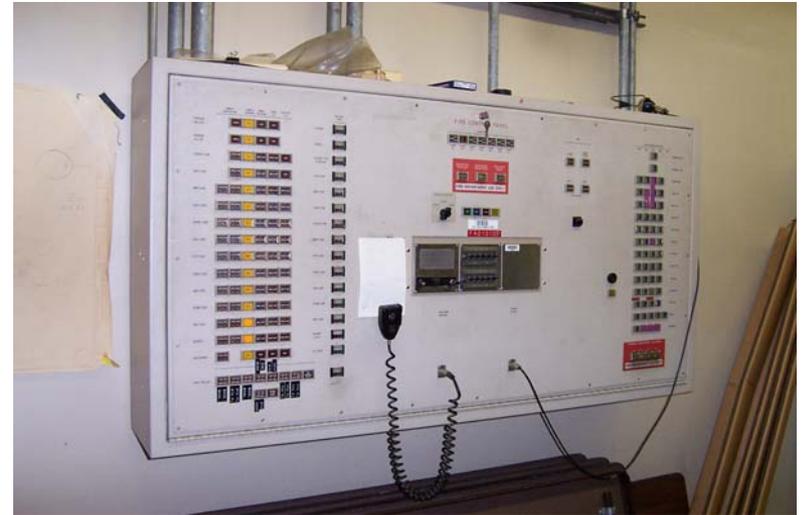
FIRE ALARM SYSTEM

- INSTALLED 1976 AS PROTOTYPE
- REPLACEMENT PARTS NOT AVAILABLE
- PROVIDE NEW STATE OF THE ART CODE COMPLIANT FIRE COMMAND CENTER
- CONSTRUCTABILITY
- ESTIMATED CONSTRUCTION COST, \$1,288,338.00

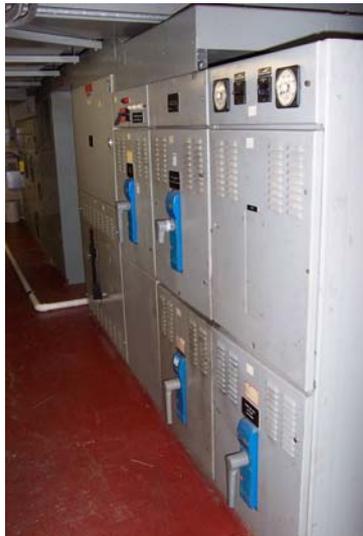
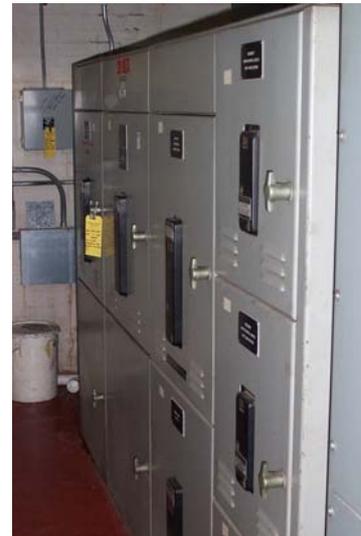
ELECTRICAL SWITCHGEAR EAST BUILDING

- INSTALLED 1955 WELL EXCEEDED LIFE EXPECTANCY
- EQUIPMENT IS AN EXTREME HAZARD TO MAINTENANCE EMPLOYEES
- REPLACEMENT PARTS NOT AVAILABLE
- PROVIDE NEW ELECTRICAL SERVICE EQUIPMENT IN NEW SERVICE ROOM
- ESTIMATED CONSTRUCTION COST, \$503,864.00

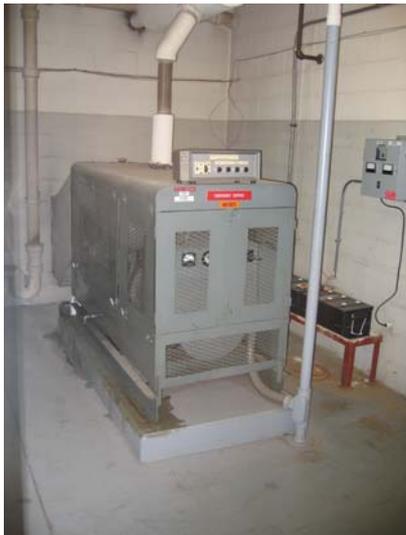
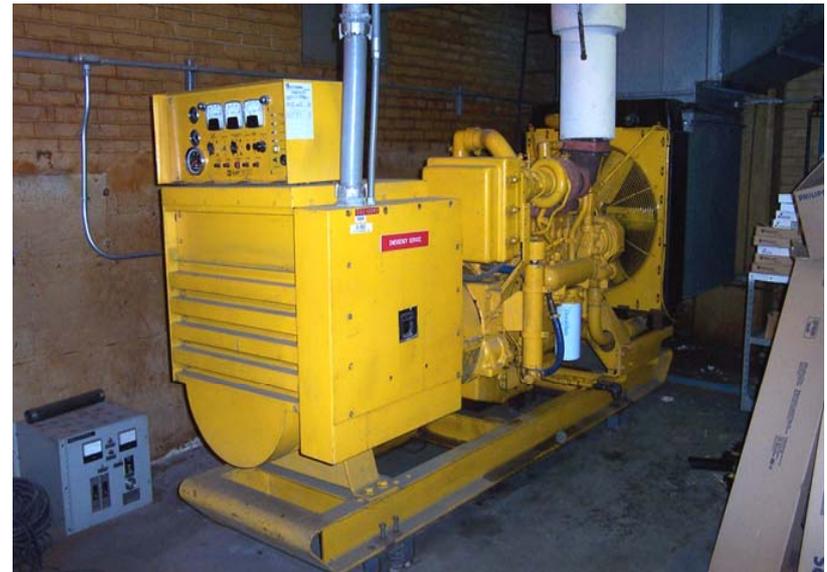
EMERGENCY POWER SYSTEM

- 2 GENERATORS INSTALLED 1955, 1976,
- NEED ADDITIONAL ELEVATOR ON EMERGENCY POWER TO SAFELY EVACUATE BUILDING
- PROVIDE NEWER LARGER GENERATOR
- ESTIMATED CONSTRUCTION COST, \$692,575.00

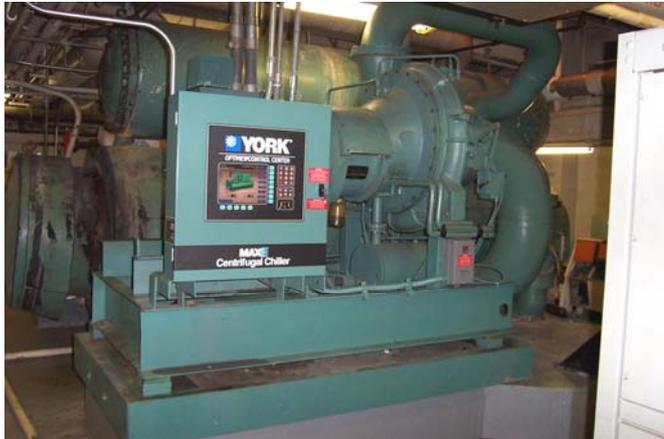
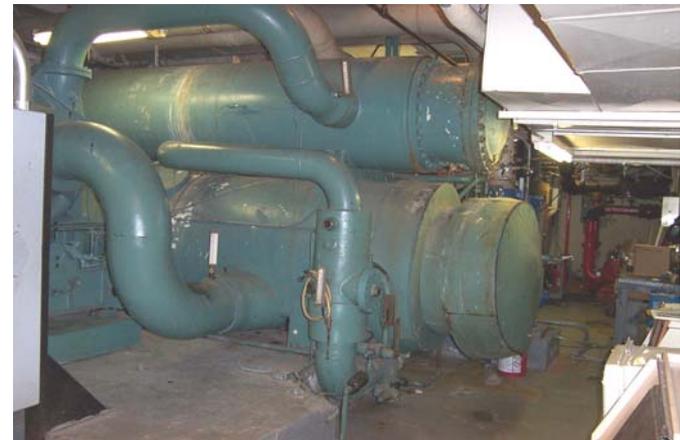
- BACK-UP CHILLER – EAST WING, 400 T, YORK, REBUILT 1976
- LAST MODEL STILL IN USE
- REPLACEMENT PARTS NOT AVAILABLE
- ESTIMATED CONSTRUCTION COST, \$656,064.00

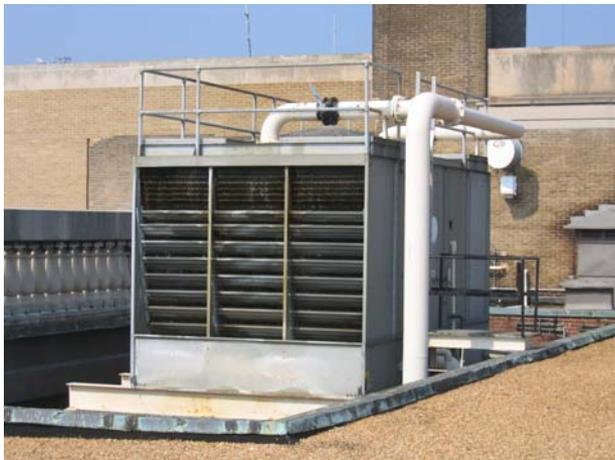
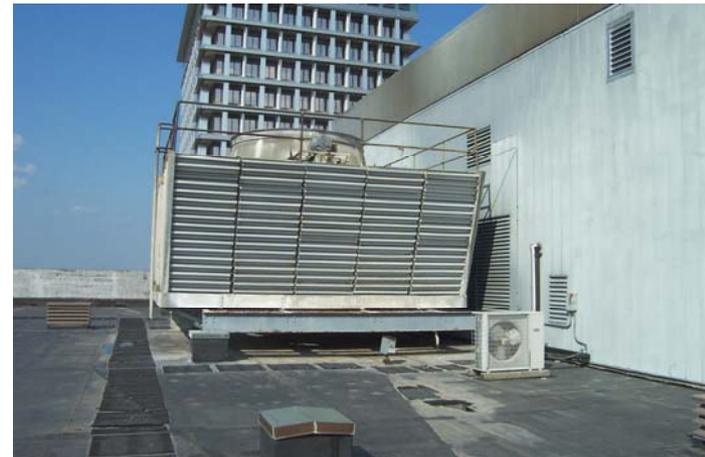
COOLING TOWERS EAST AND WEST BUILDINGS

- INSTALLED 1976
- POOR CONDITION, EXCEEDED USEFUL LIFE
- PROVIDE NEW COOLING TOWER, 500 TONS, WEST BUILDING ROOF
- RELOCATE COOLING TOWER FROM WASHINGTON BUILDING, 400 TON, WEST BUILDING ROOF
- INTERCONNECT COOLING TOWERS TO PROVIDE REDUNDANCY
- ESTIMATED CONSTRUCTION COST, \$369,999.00

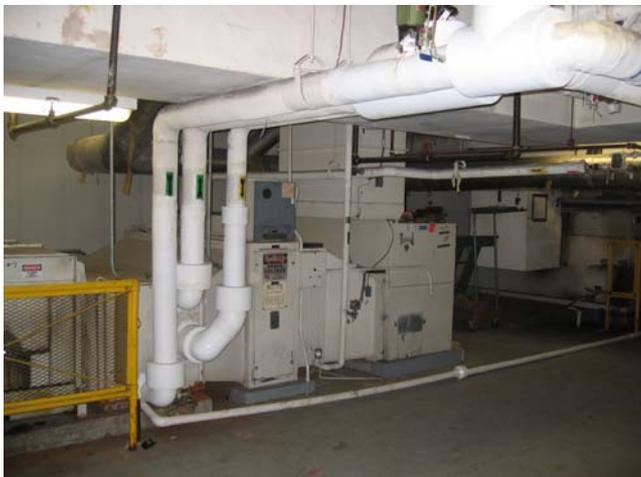
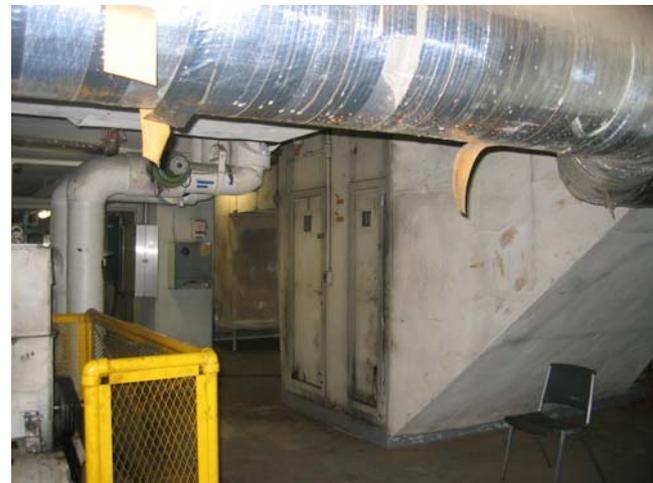
Air Handling Units East and West Building

- AHU'S INSTALLED 1965 – WEST BUILDING
- AHU'S INSTALLED 1976 – EAST BUILDING
- AHU'S HAVE EXCEEDED LIFE EXPECTANCY
- NEWER EQUIPMENT MORE ENERGY EFFICIENT
- DIRECT DIGITAL CONTROLS ALLOW MORE LOAD DIVERSITY

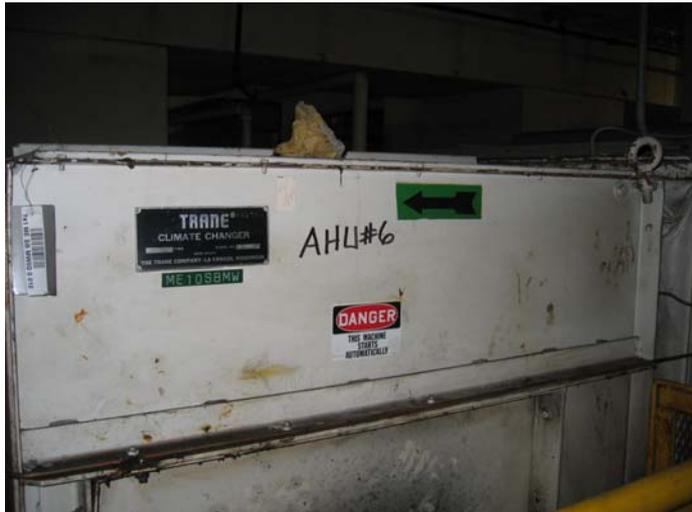
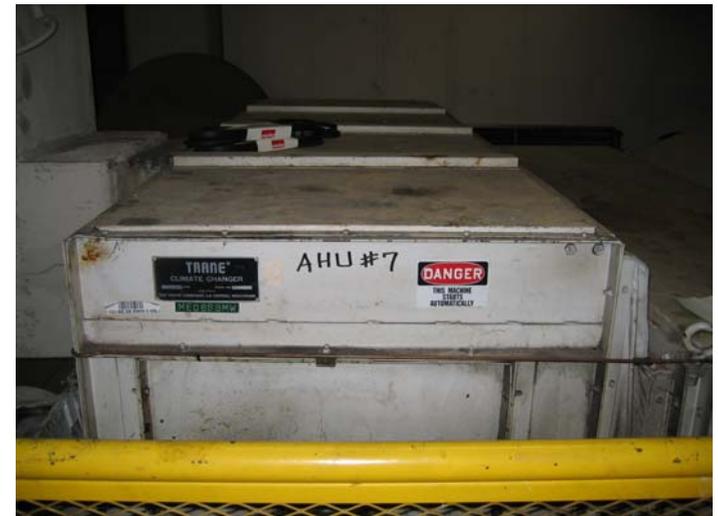
AIR HANDLING UNITS – WEST BUILDING

PRIORITY	AHU #	LOCATION	AREA SERVED
1	5, 6, 7	Sub-Basement	Perimeter (All Floors)
3	1 & 2	Sub-Basement	Interior (B, 1, 2, 3, 4 th Floors)
2	3 & 4	9 th Floor Mechanical Room	Interior (5, 6, 7, 8, 9 th Floors)
	7 AHU

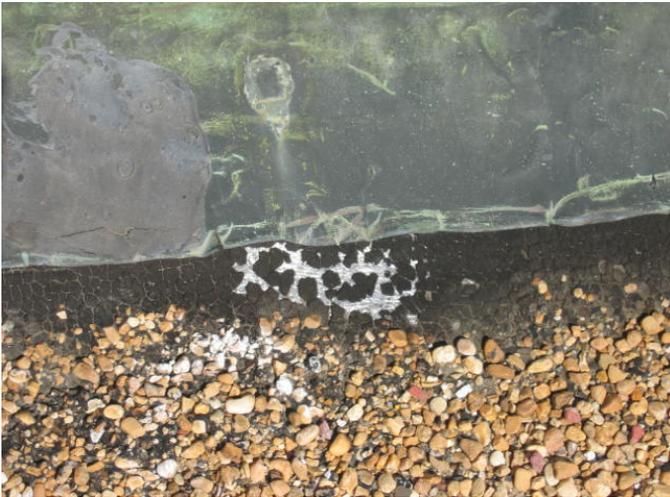
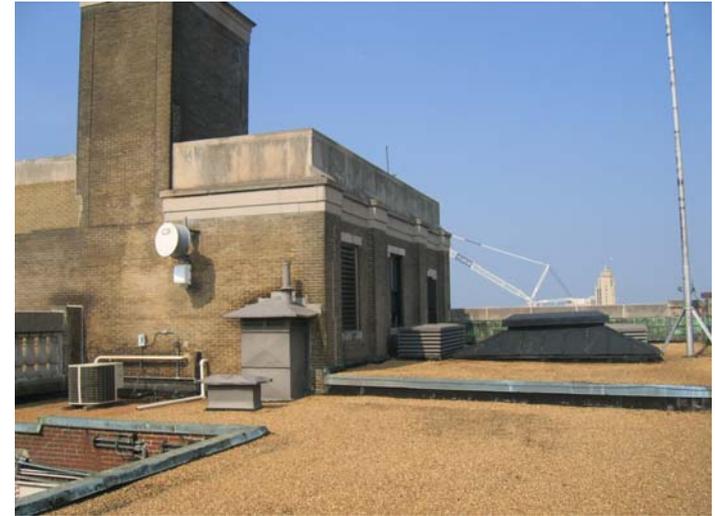
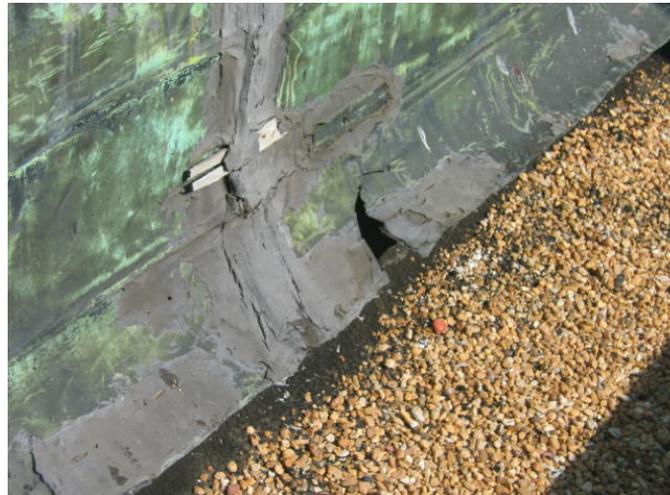
ROOFING – EAST BUILDING

- ROOFING POOR CONDITION, NEED TO BE REPLACED 6TH, 7TH, 8TH, 12TH FLOORS
- ASBESTOS MAY BE PRESENT IN FLASHING
- INSTALL NEW ROOFING, FLASHING CURBS AND COPING

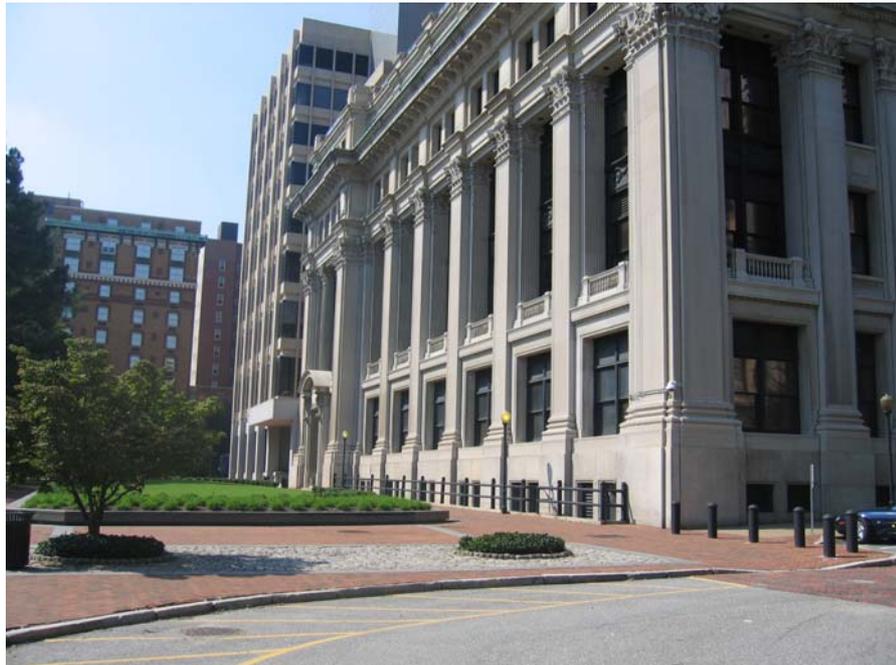
ROOF DRAIN RISERS – EAST BUILDING

- ROOF DRAINS ARE NOT SEALED, OPEN JOINTS LEAKING
- WATER ACCUMULATING SECOND FLOOR BALCONY STRUCTURE
- HOUSE ROOM D
- REPAIR ROOF DRAIN PIPING
- INSTALL SCUPPERS IN BALCONIES

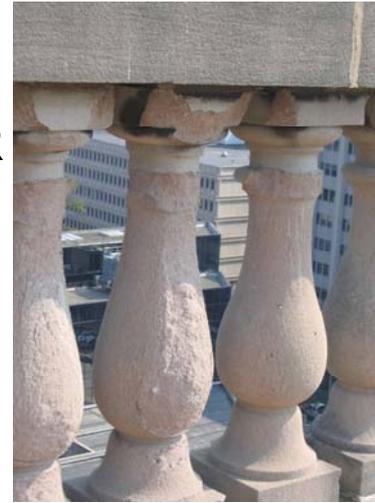
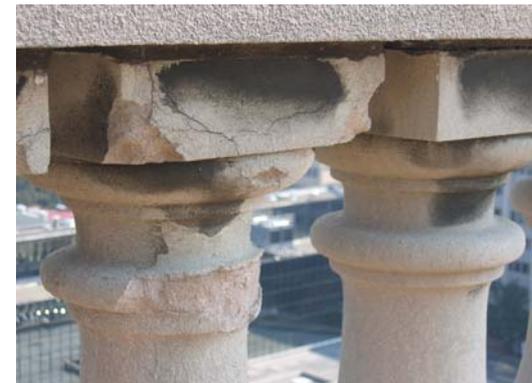
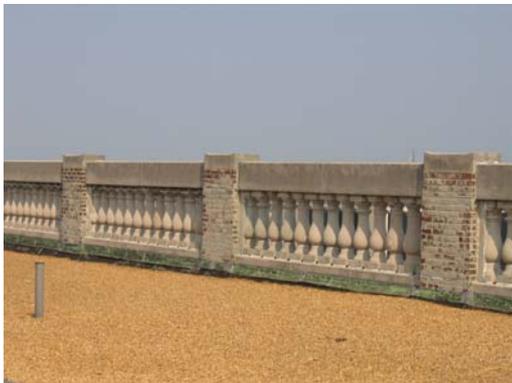
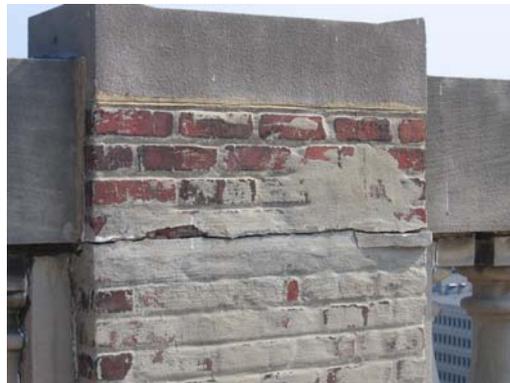
BUILDING EXTERIOR – EAST BUILDING

- 1923 BUILDING ROOF PERIMETER
- EXISTING CONCRETE BALUSTERS, RAILING MASONRY PIER DETERIORATING
- DEBRIS MAY FALL ON BROAD STREET
- REPLACE CONCRETE BALUSTERS AND RAILING WITH URETHANE BALUSTERS
- REPAIR MASONRY PIERS
- ESTIMATED CONSTRUCTION COST, \$894,009.00

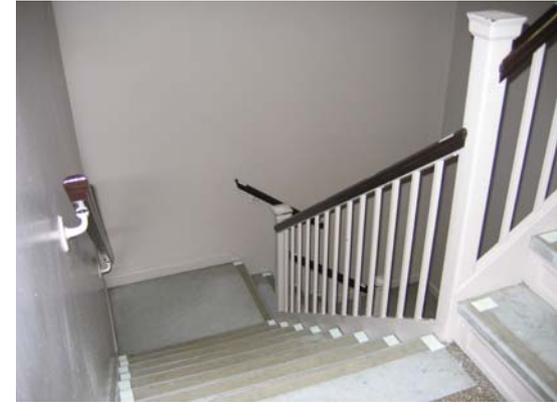
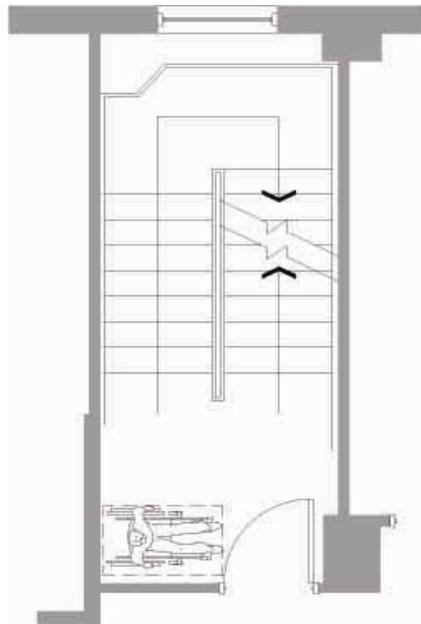
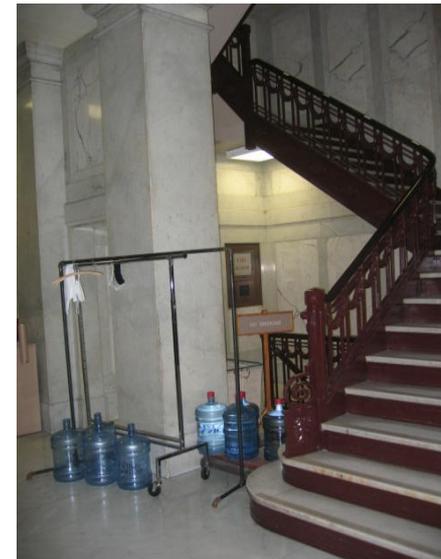
LIFE SAFETY CODE ISSUES

- STAIRWELLS DO NOT HAVE 2HR RATINGS
- STAIRWELLS DO NOT HAVE AREAS OF REFUGE
- ASBESTOS ABATEMENT
- ESTIMATED CONSTRUCTION COST, \$685,706.00
