## **The Rotunda at UVA**

## **Rotunda Roof Replacement**

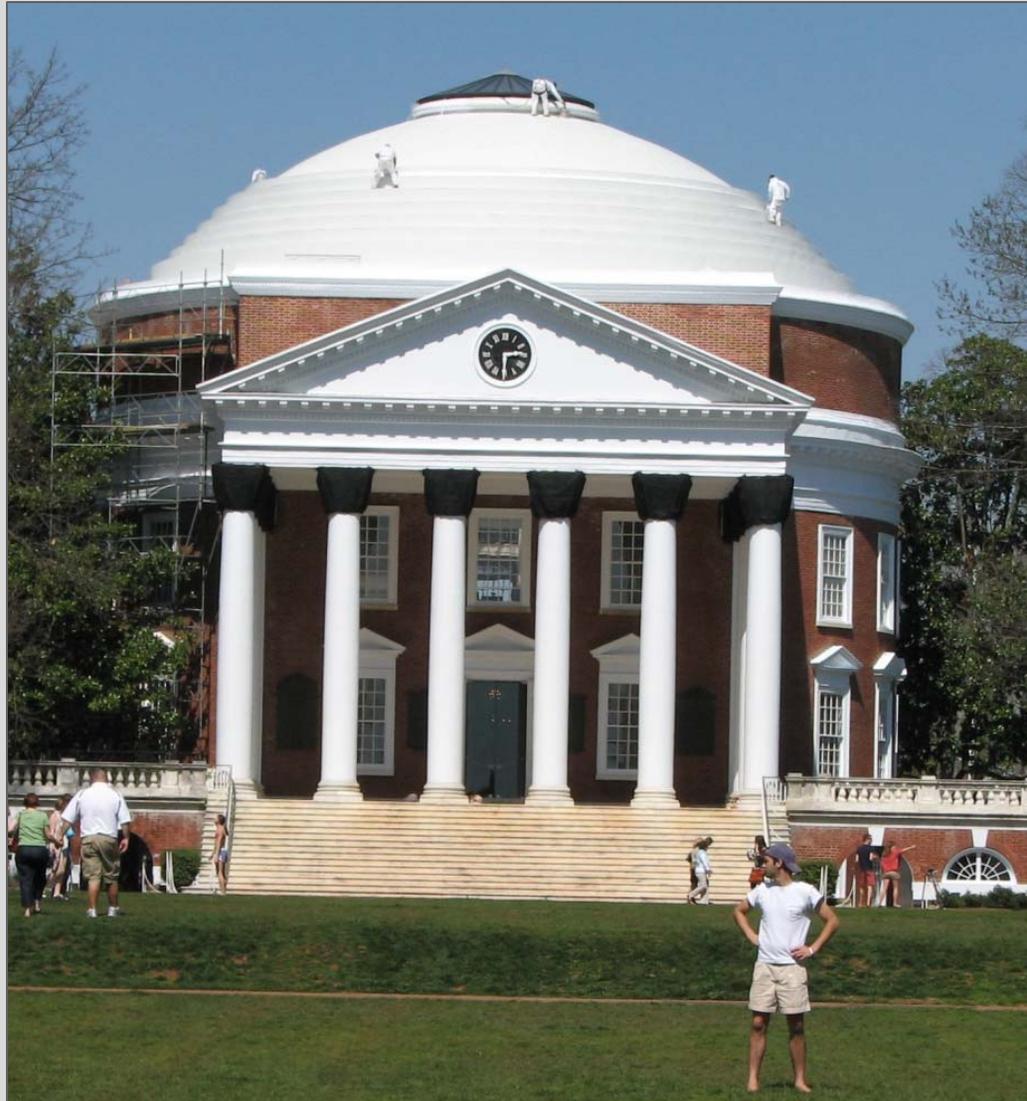
**Roof painting, marble capitals netted, Spring 2010**

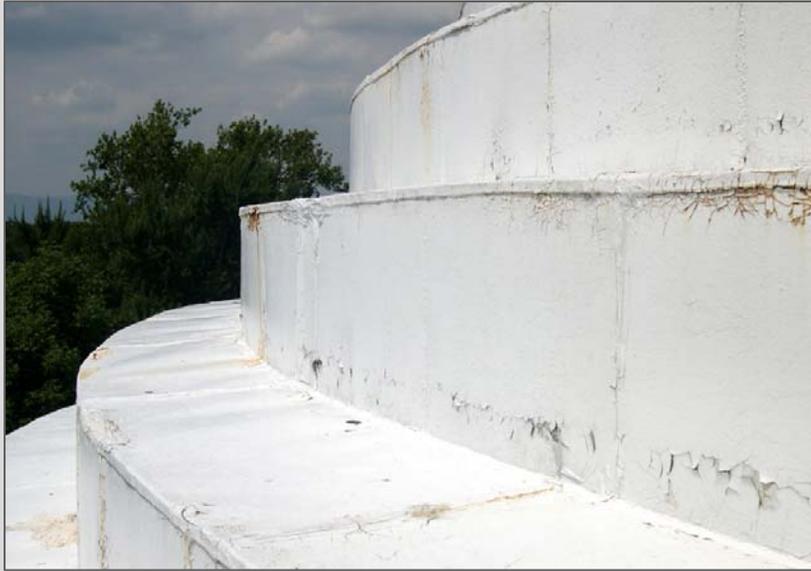
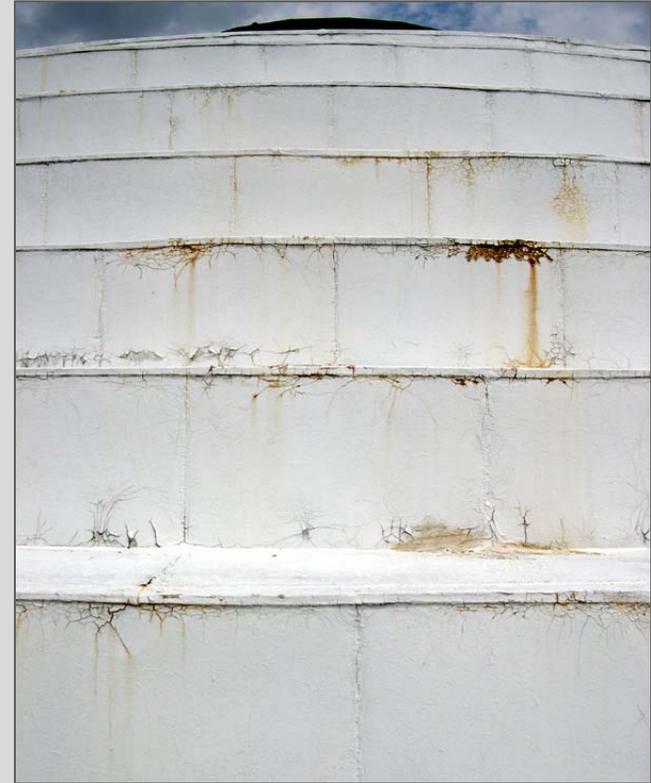
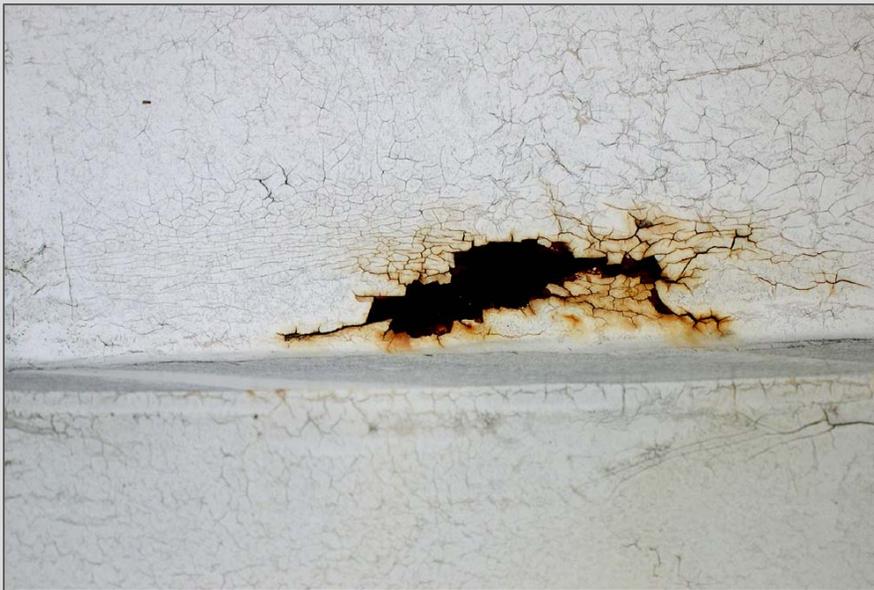
**Various Conditions at Sheet Metal Roof**

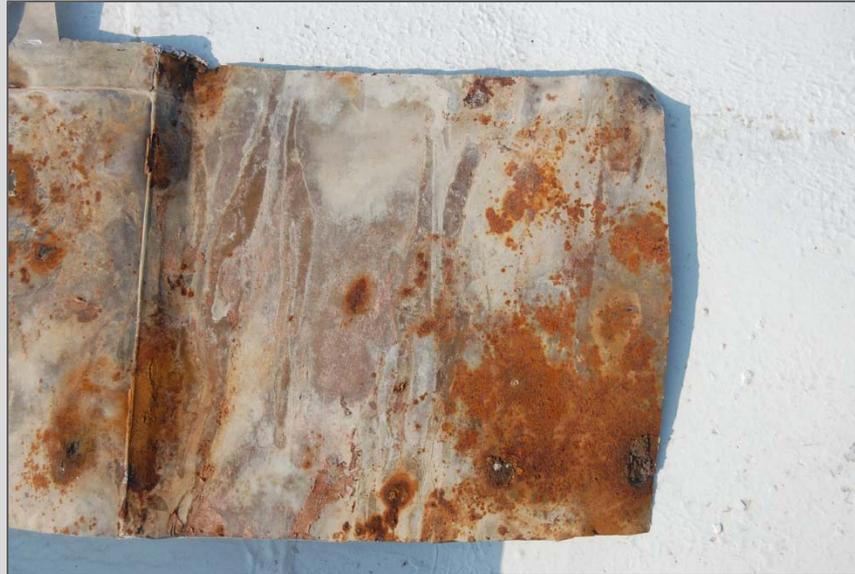
**Sheet metal rusting from below**

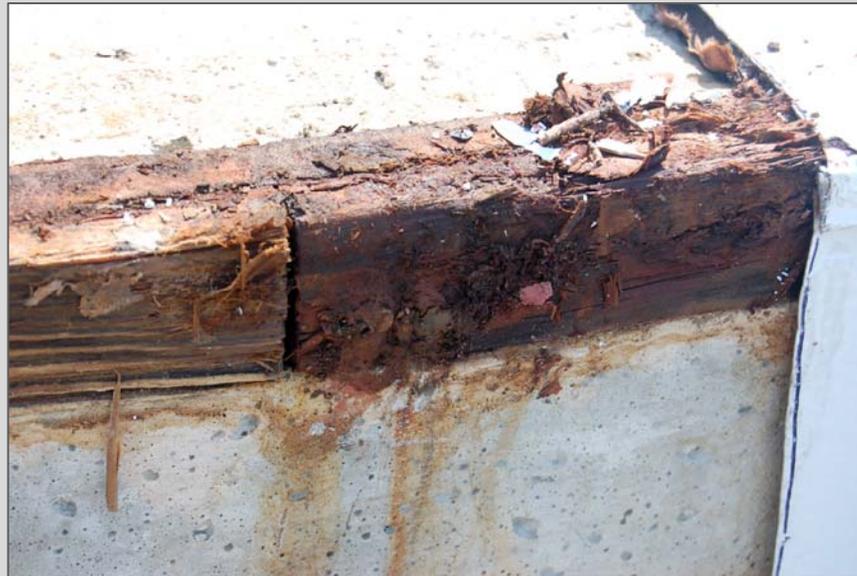
**Rotting wooden nailers**

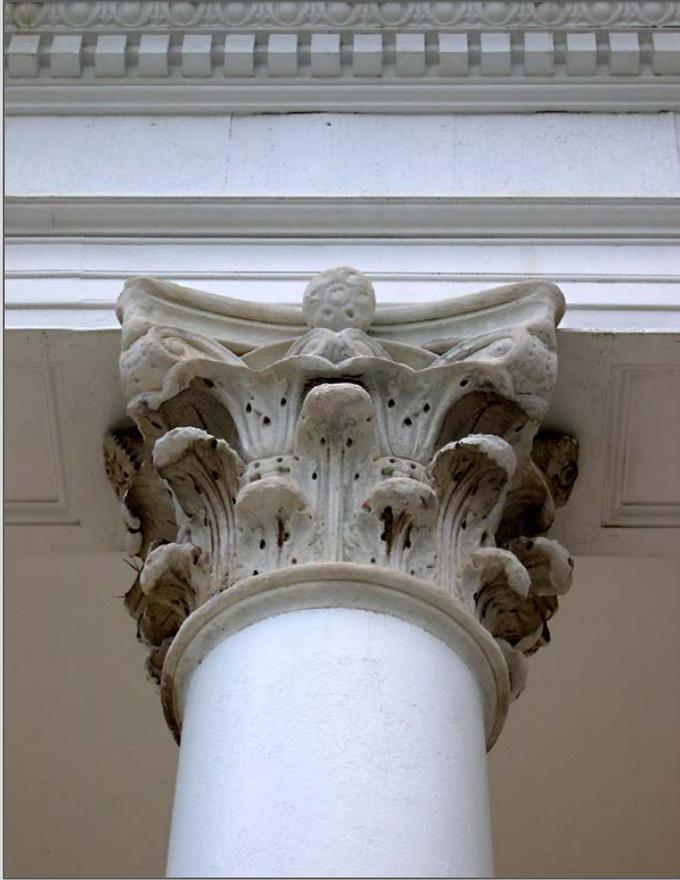
**Erosion seen from below**

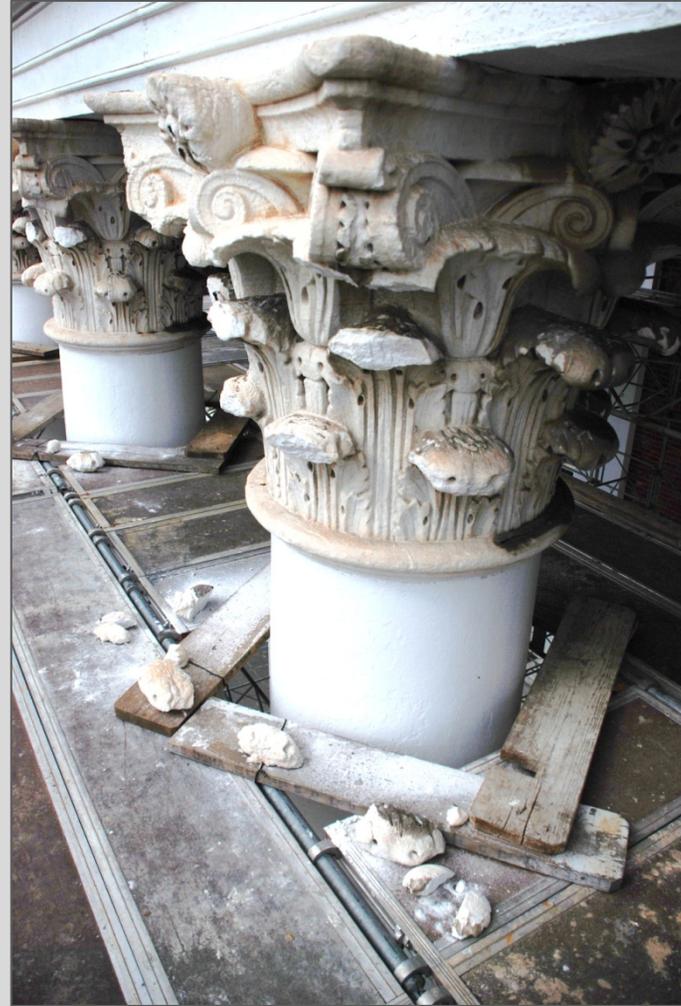
**Pieces of capitals removed for security**

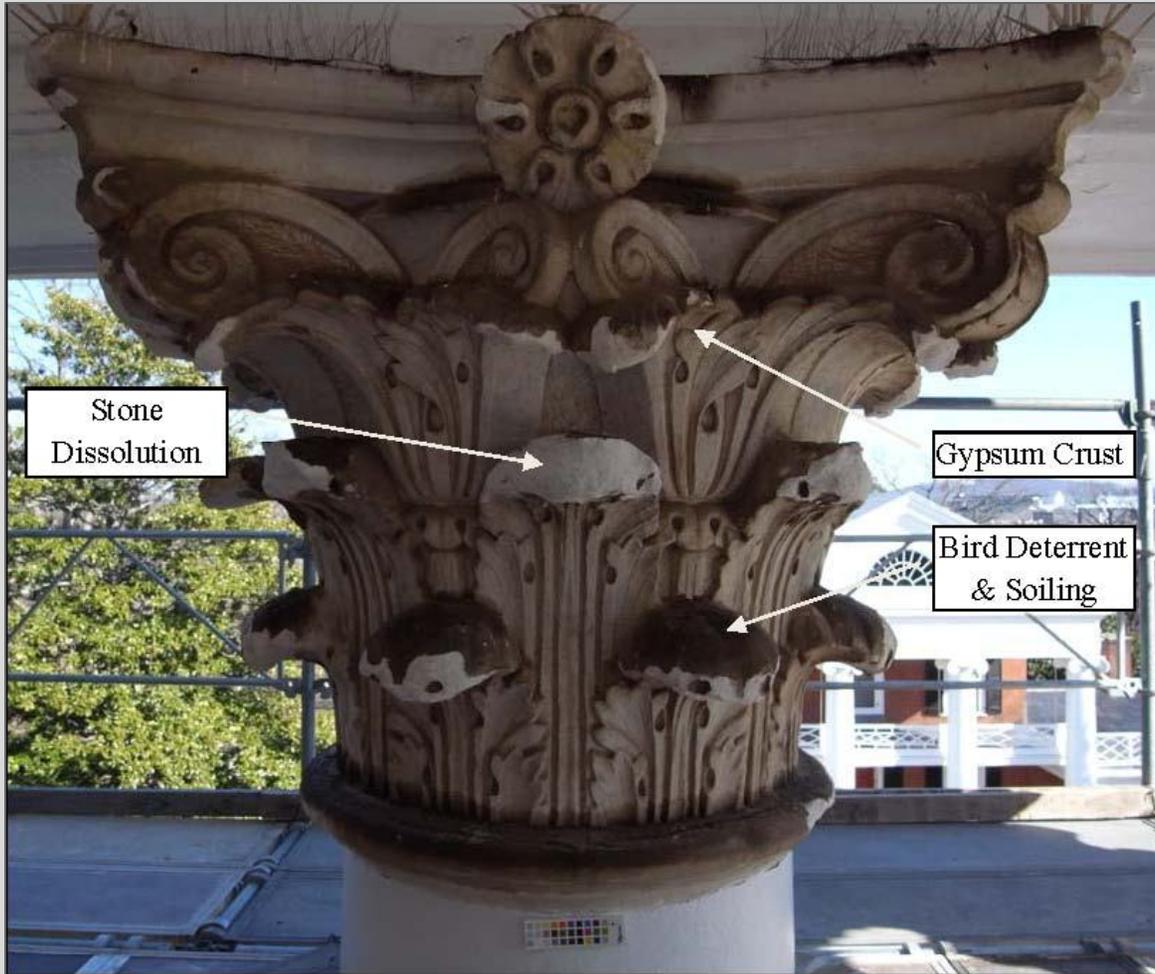
Column capital on the South Portico showing typical conditions. Note several missing acanthus leaves

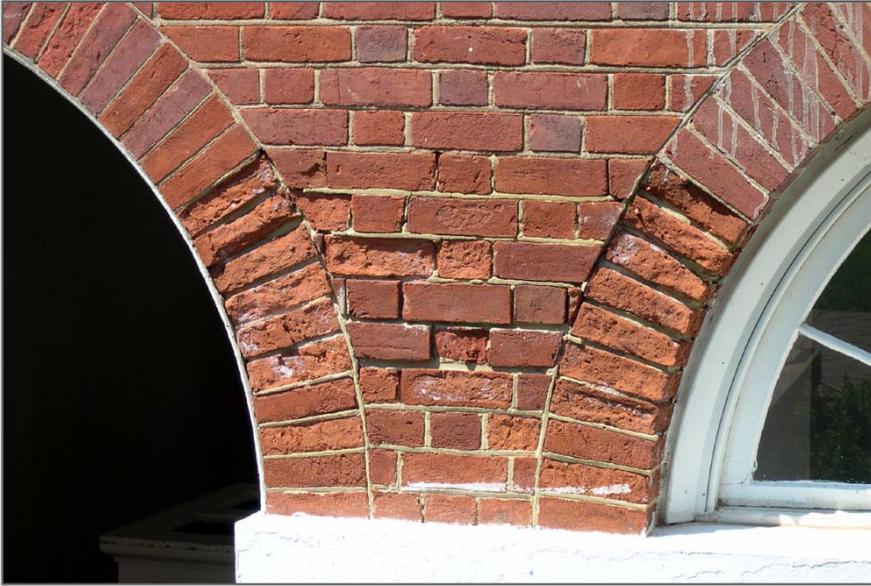
**Badly damaged brick at southeast corner**

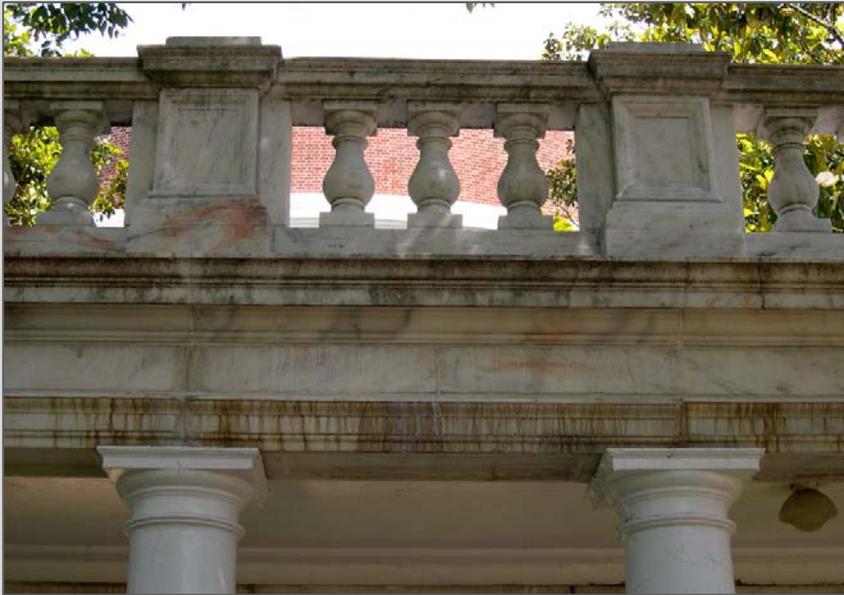
**Moss, red mold and stains on marble**

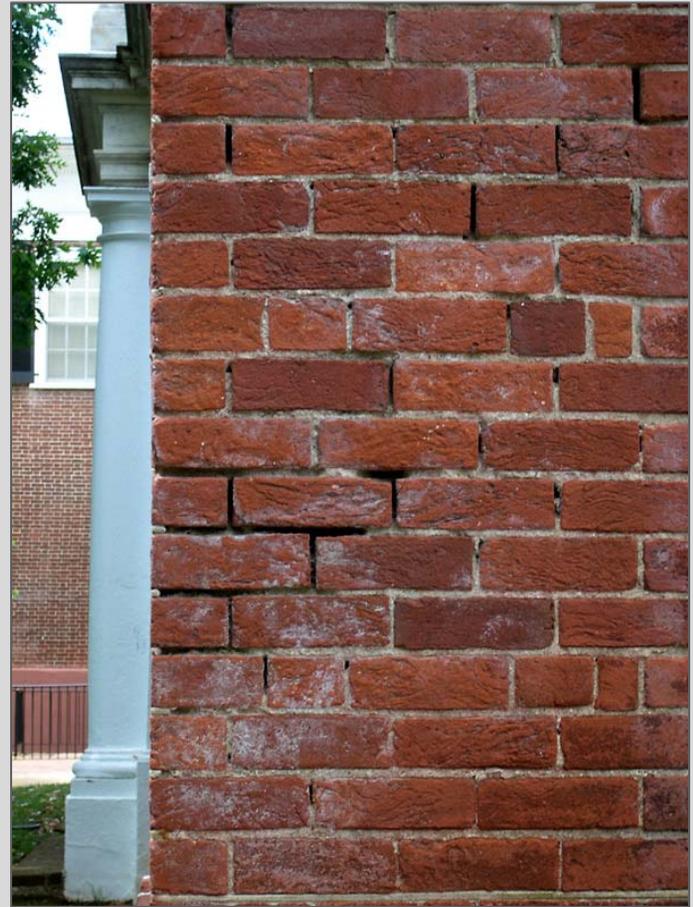
**Open joints, stains and damage from salts on northeast corner**
