Update General Assembly Building and Old City Hall June 20, 2013

General Assembly Building Assessment

Old City Hall

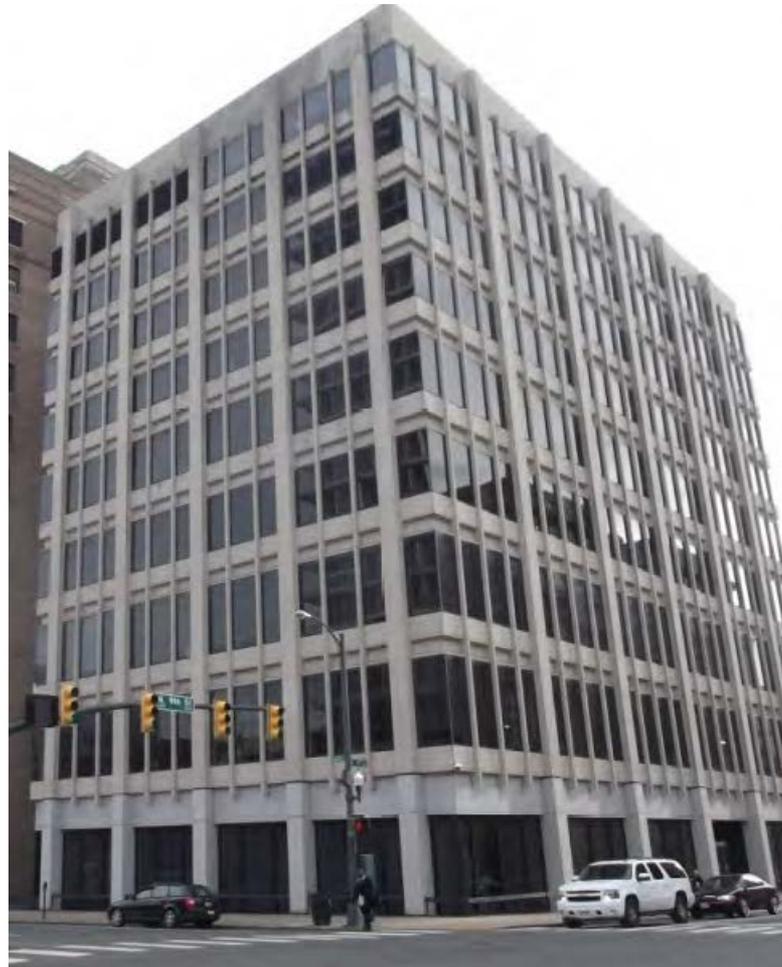
Asbestos Fireproofing in West Section

Monthly Air Testing

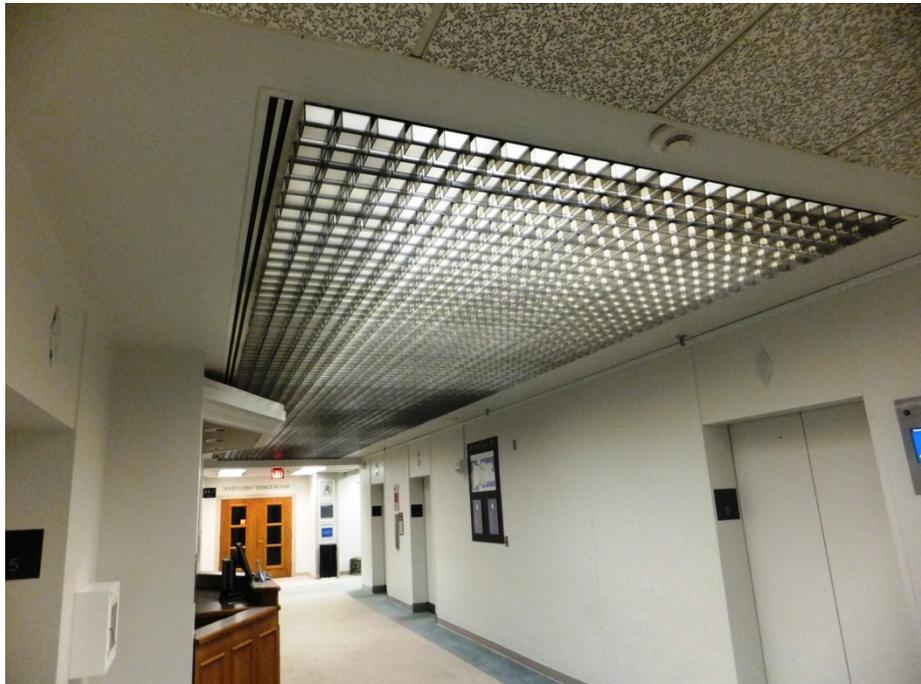
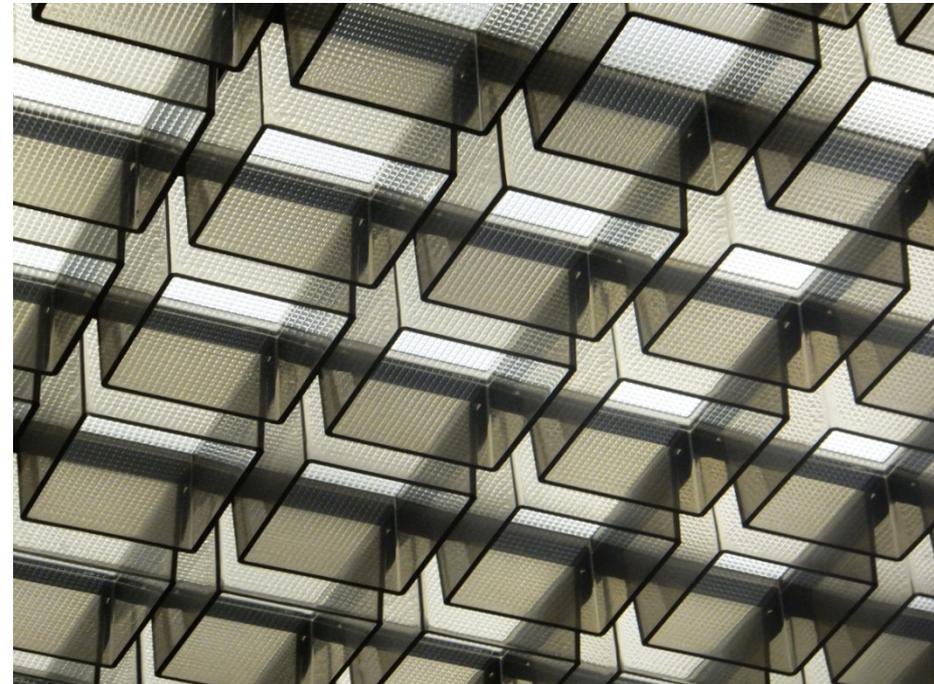
Asbestos Fireproofing in West Section

Due to required environmental controls, changing bulbs in this light grid costs \$400 each time any number of bulbs are replaced.

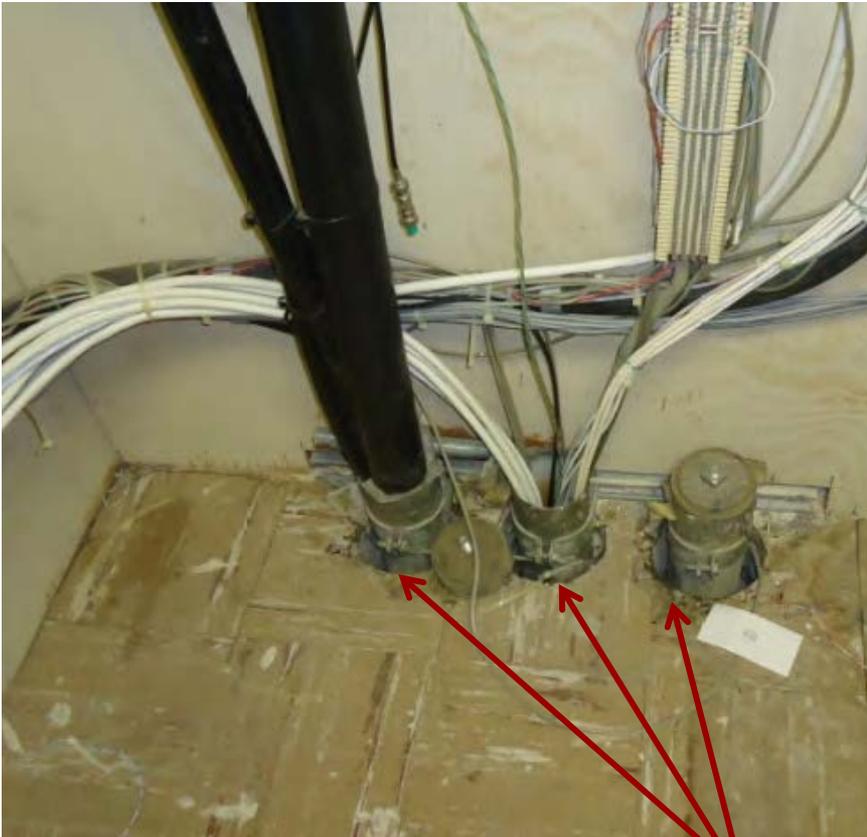
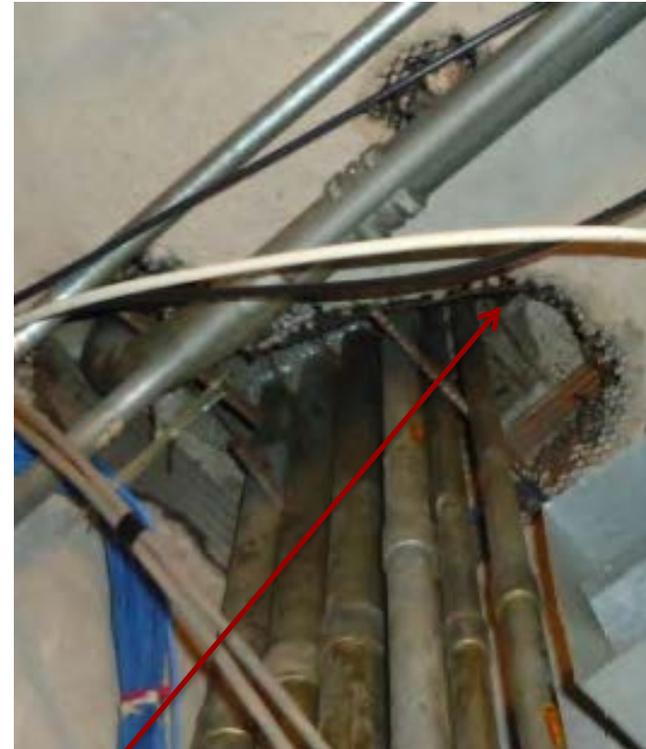
Multiple Fire and Life Safety Code Issues

Note floor-to-floor penetration gaps

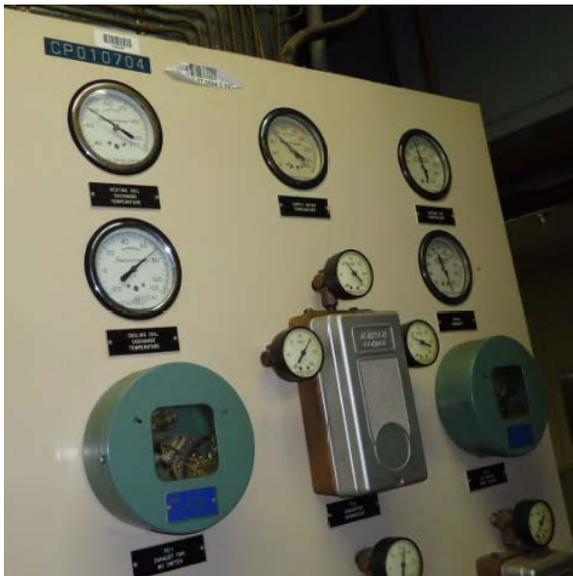
Air Handling Units/HVAC

~1970s era controls

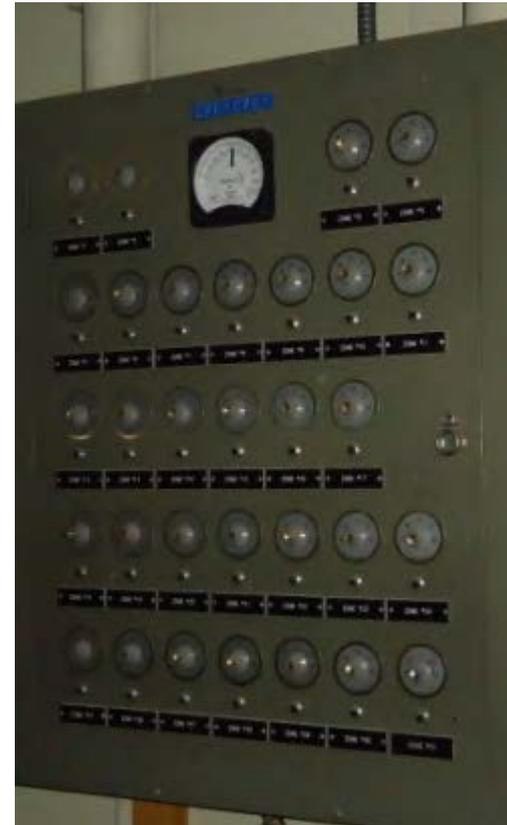
Pneumatic controls; generally on or off; energy inefficient

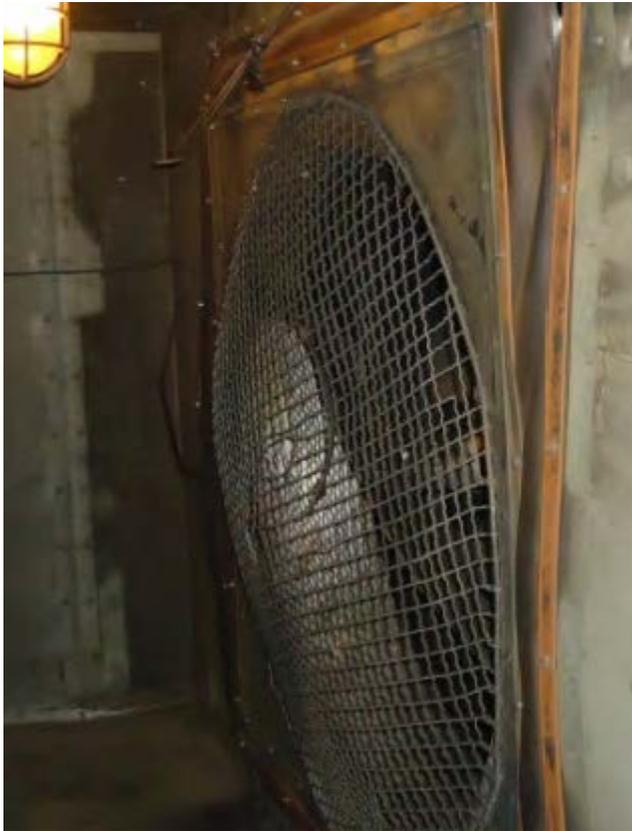
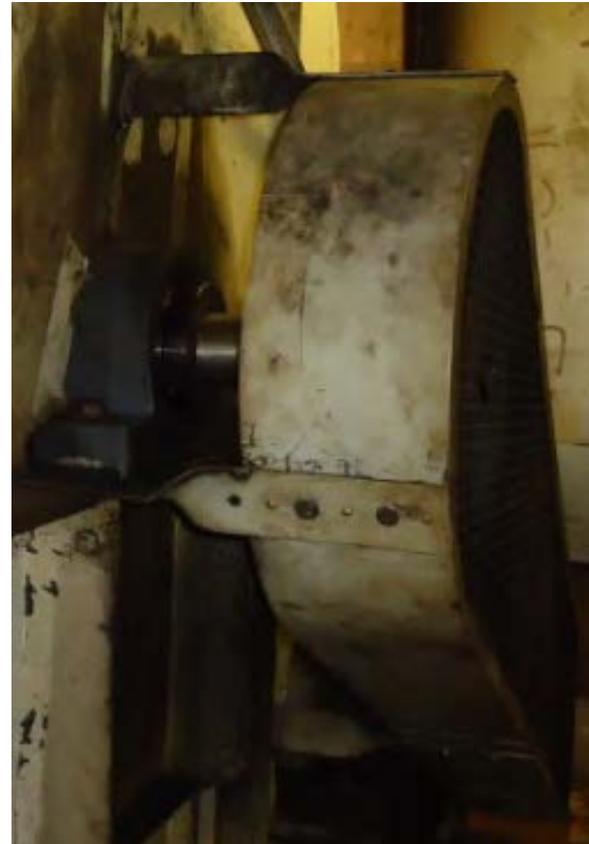
Air Handling Units/HVAC

Obsolete fan units; repair parts no longer available and must be custom-made...often extended “down time.”

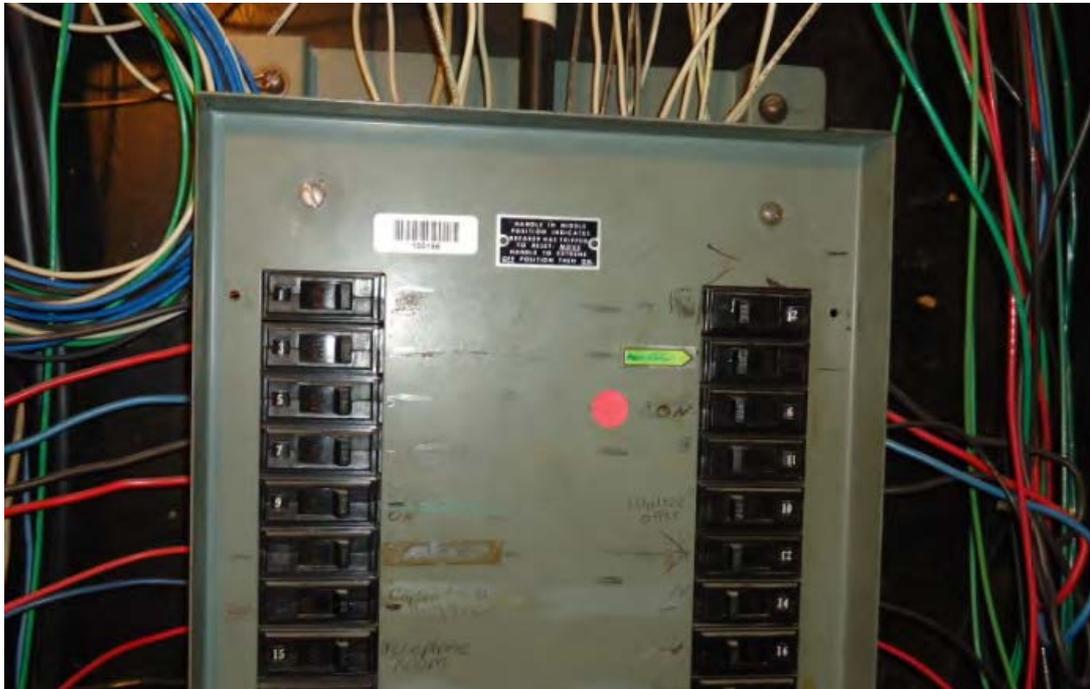
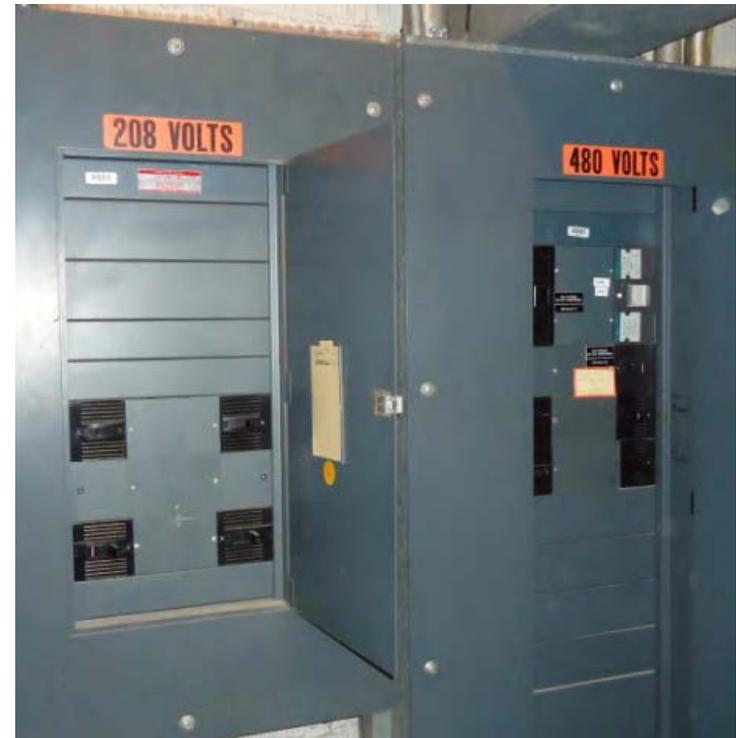
Electrical Distribution Network

Obsolete equipment; majority of electrical distribution system in service for 40-60 years

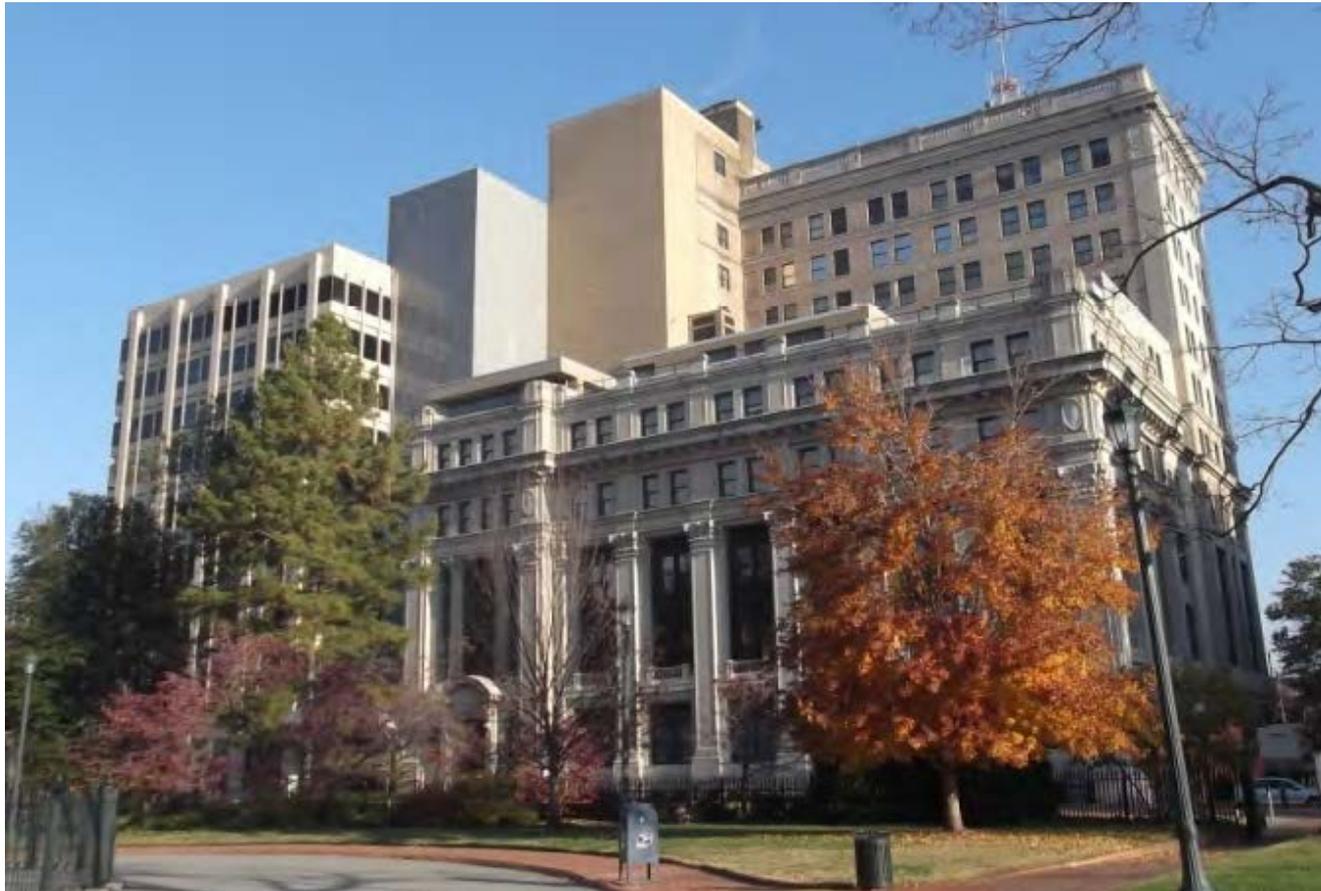
Complexity

~ 4 Separate Buildings Constructed Between 1912-1965 and Combined in 1976

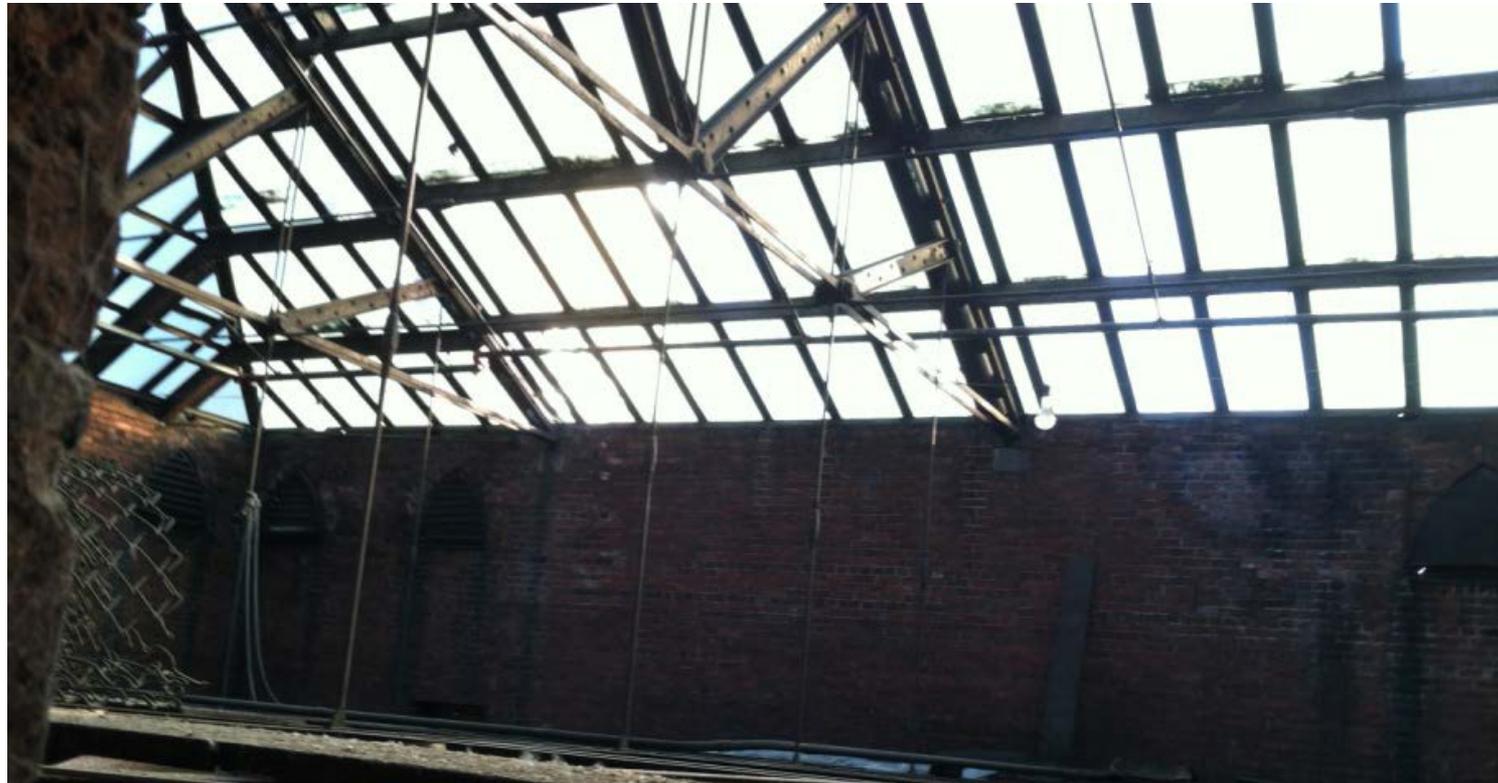
Old City Hall, Atrium Roof Leaks

Glass ceiling leaks throughout. Ceiling cannot be repaired without full renovation.

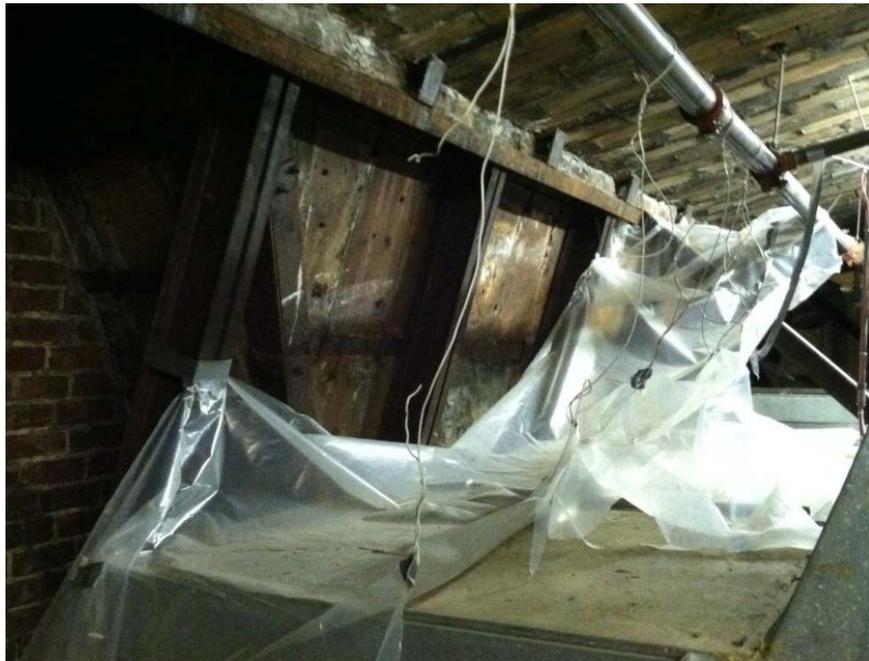
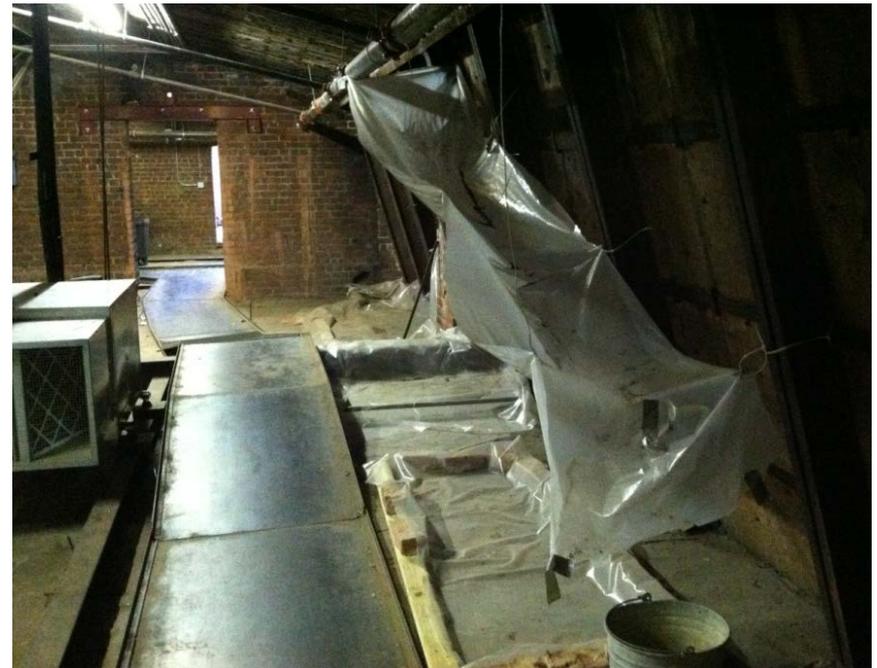
Old City Hall, Penthouse Roof Leaks

Sagging areas on flat roof sections leads to large and prolonged puddling, contributing to roof leaks.

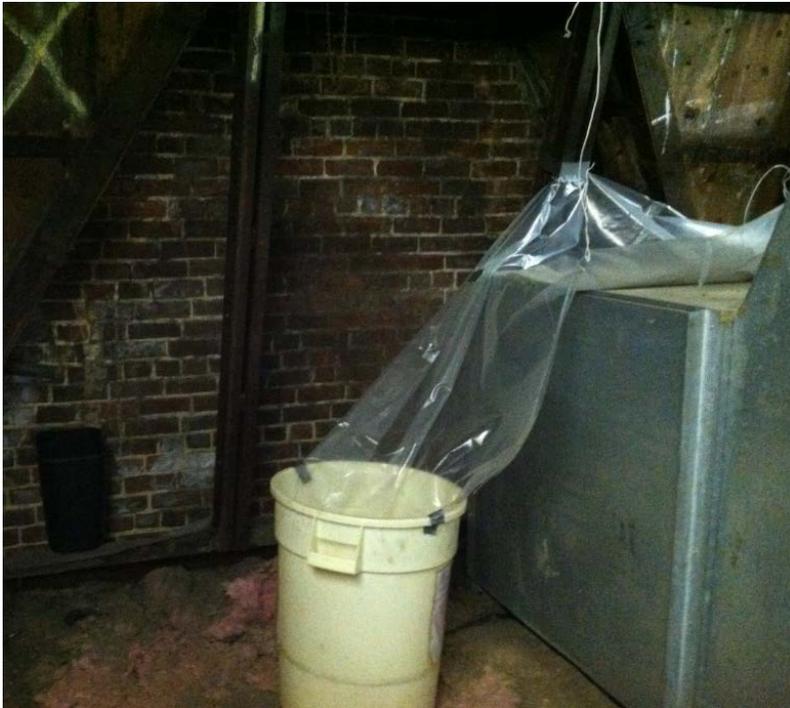
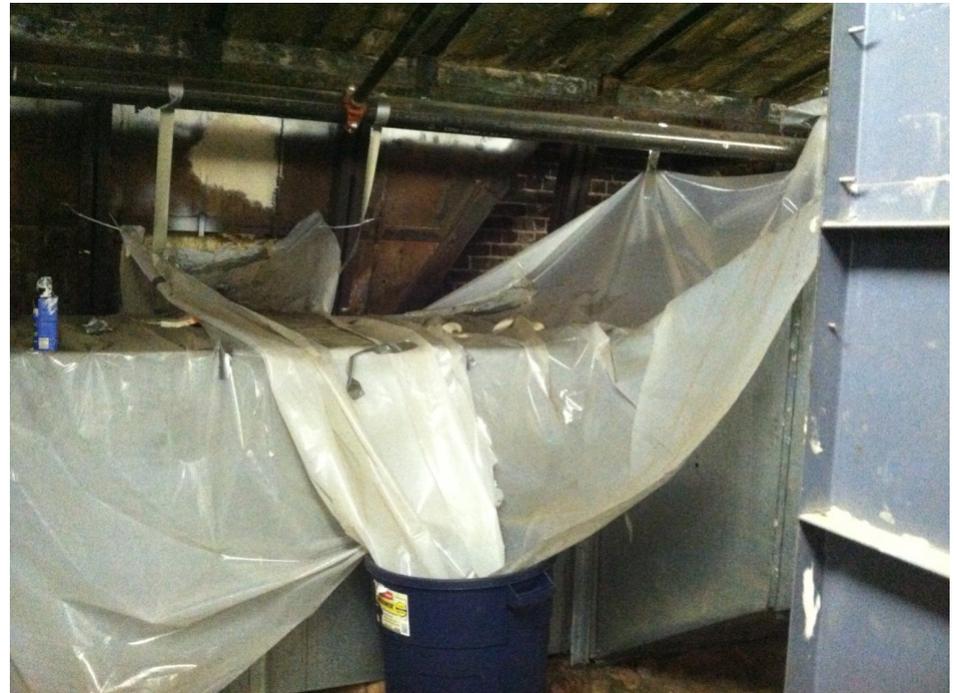
Old City Hall, Penthouse Roof Leaks

Sagging areas on flat roof sections leads to large and prolonged puddling, contributing to roof leaks.

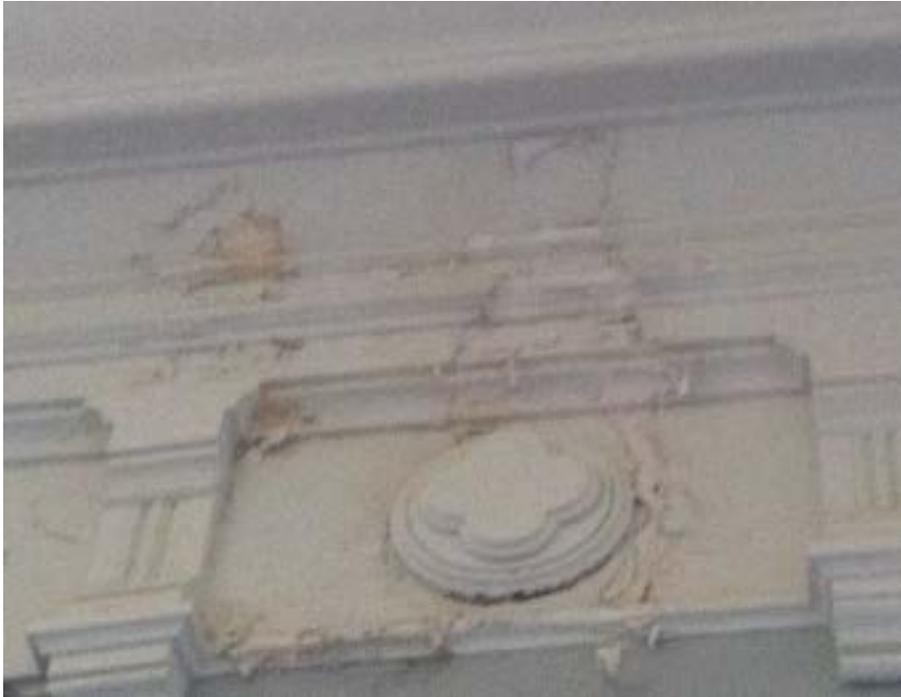
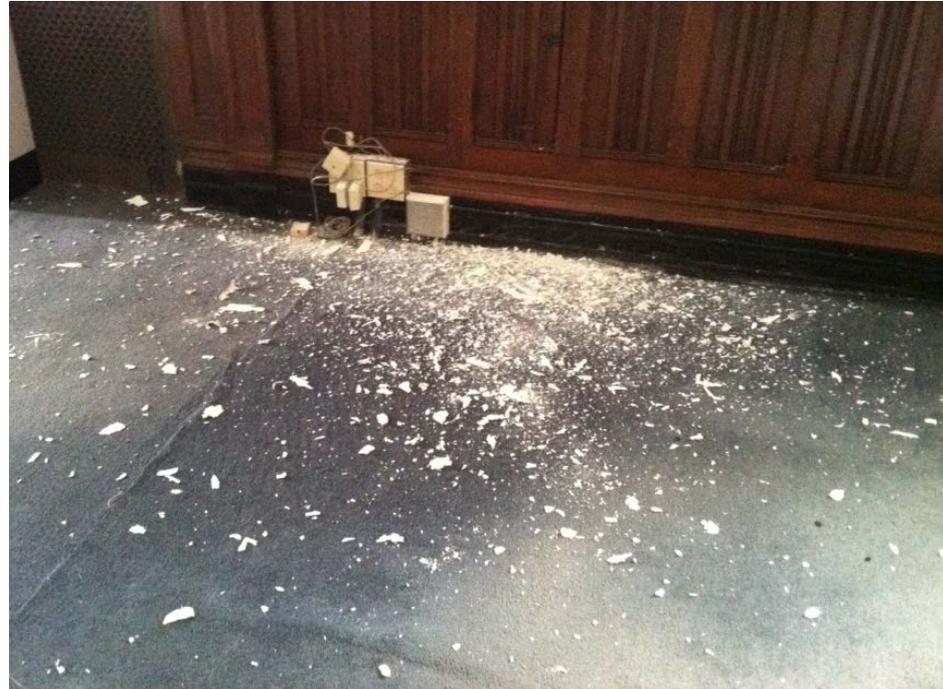
Old City Hall, Wall Leaks

Water infiltration due to improper roof drainage and malfunctioning downspouts: damage to walls and carpet in prime office suite.

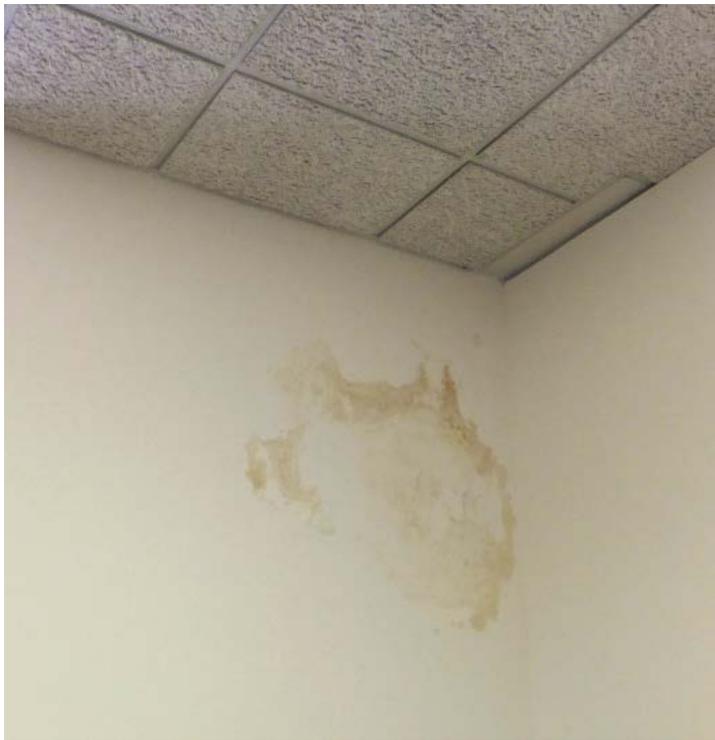
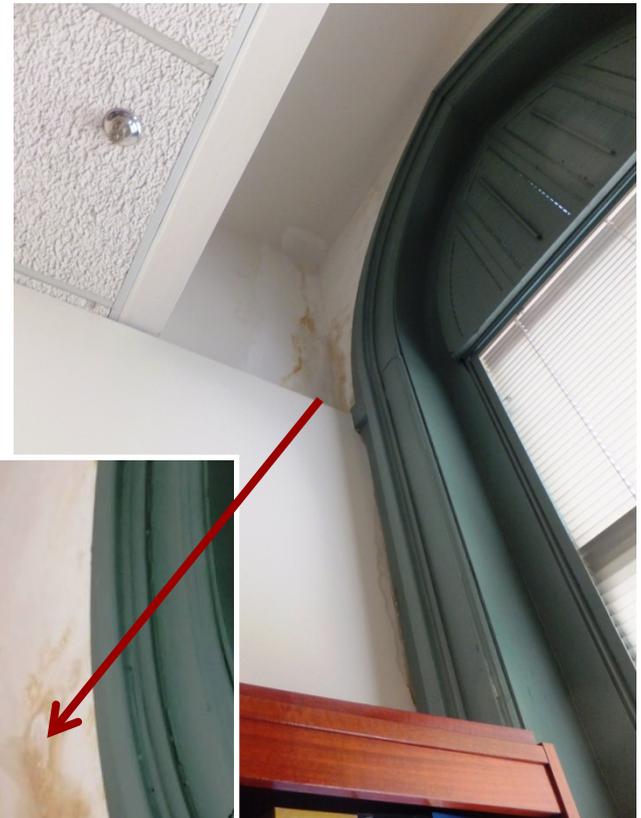
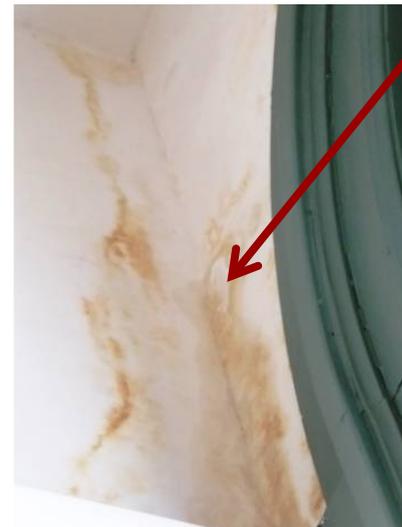
Old City Hall, Wall Leaks

Significant water damage on interior walls.

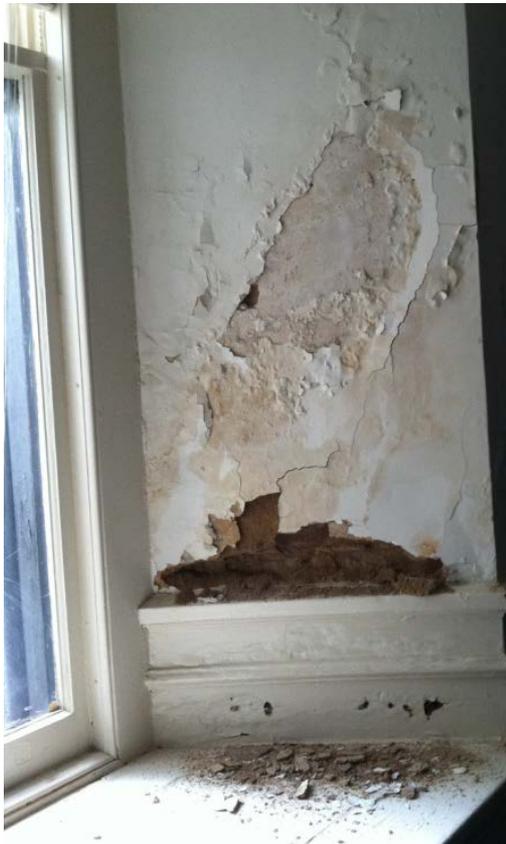
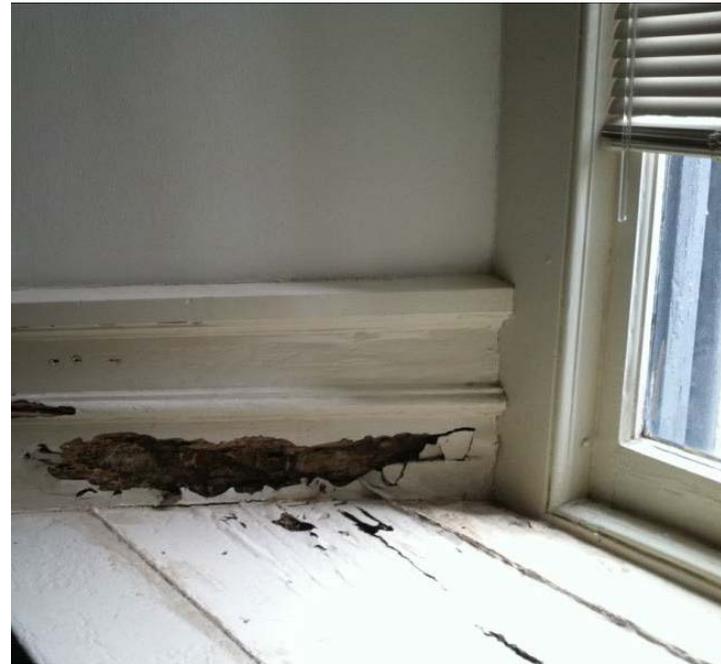
Old City Hall, Wall Leaks

Wall sections rotting and widespread water infiltration in lower level office spaces making them unable to be occupied.
